Manhole Inspection Summary

Manhole # S25A__020MH

Location Address: **1208 HARLEM AVE**

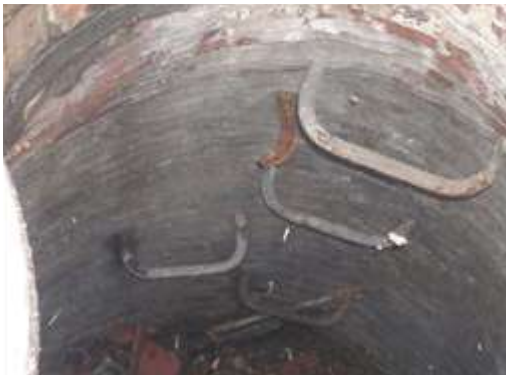
Defect 4

Steps Count: **4** Missing: **1** ☐ Corroded

MISSING STEP

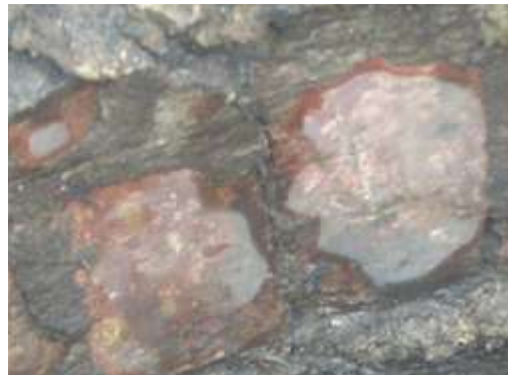
Defect 3

Chimney / Frame Adjustment ☒ Exists Material: **Brick** ☐ Parged Height: **6** (in.)
Condition: ☐ Sound ☒ **Cracked** ☐ Root Intrusion ☐ Loose Brick ☐ Deteriorated
Infiltration: ☐ None ☐ Joint ☒ **Cracks** ☐ Mortar ☐ Roots ☐ Wall

CRACKED CHIMNEY

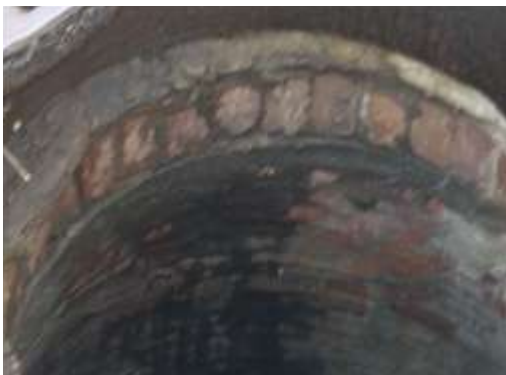
Defect 2

INFILTRATION OF CHIMNEY

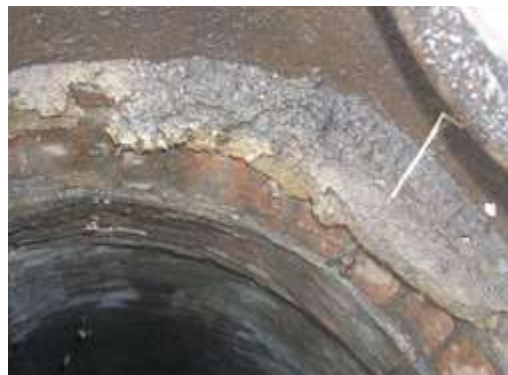
Defect 1

Frame Offset: **2** (in.) Condition: ☒ Sound ☐ Cracked ☐ Leaks

FRAME OFFSET

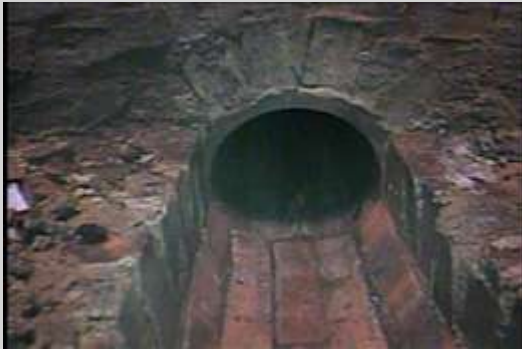
12 O'Clock Outflow

8 in. Circular Gravity Sewer
Pipe Out @ 12 O'Clock

Pipe Height: **8.4** (in.) Rod and Bar (Angled)
Pipe Material: **Clay** ☐ Pipe Lined
Invert Depth: **9.66** (ft.) Flow Characteristics: **Slow**
Deposits: ☒ None ☐ Mud ☐ Sludge ☐ Debris ☐ Grease
Silt Depth: (in.) Deposits Extent:
Infiltration: **None** Pipe Seal Cond: **Sound**

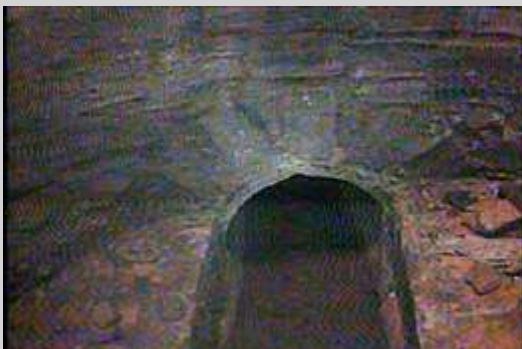
3 O'Clock Inflow

8 in. Circular Gravity Sewer
Pipe In @ 3 O'Clock

Pipe Height: **8.4** (in.) Rod and Bar (Angled)
Pipe Material: **Clay** ☐ Pipe Lined
Invert Depth: **9.37** (ft.) Flow Characteristics: **Slow**
Deposits: ☒ None ☐ Mud ☐ Sludge ☐ Debris ☐ Grease
Silt Depth: (in.) Deposits Extent:
Infiltration: **None** Pipe Seal Cond: **Sound**
